LEHIGH RIVER BASIN  
POHOPOCO CREEK, PENNSYLVANIA

# BELTZVILLE LAKE

CONDITION REPORT

PERIODIC INSPECTION REPORT NO. 5

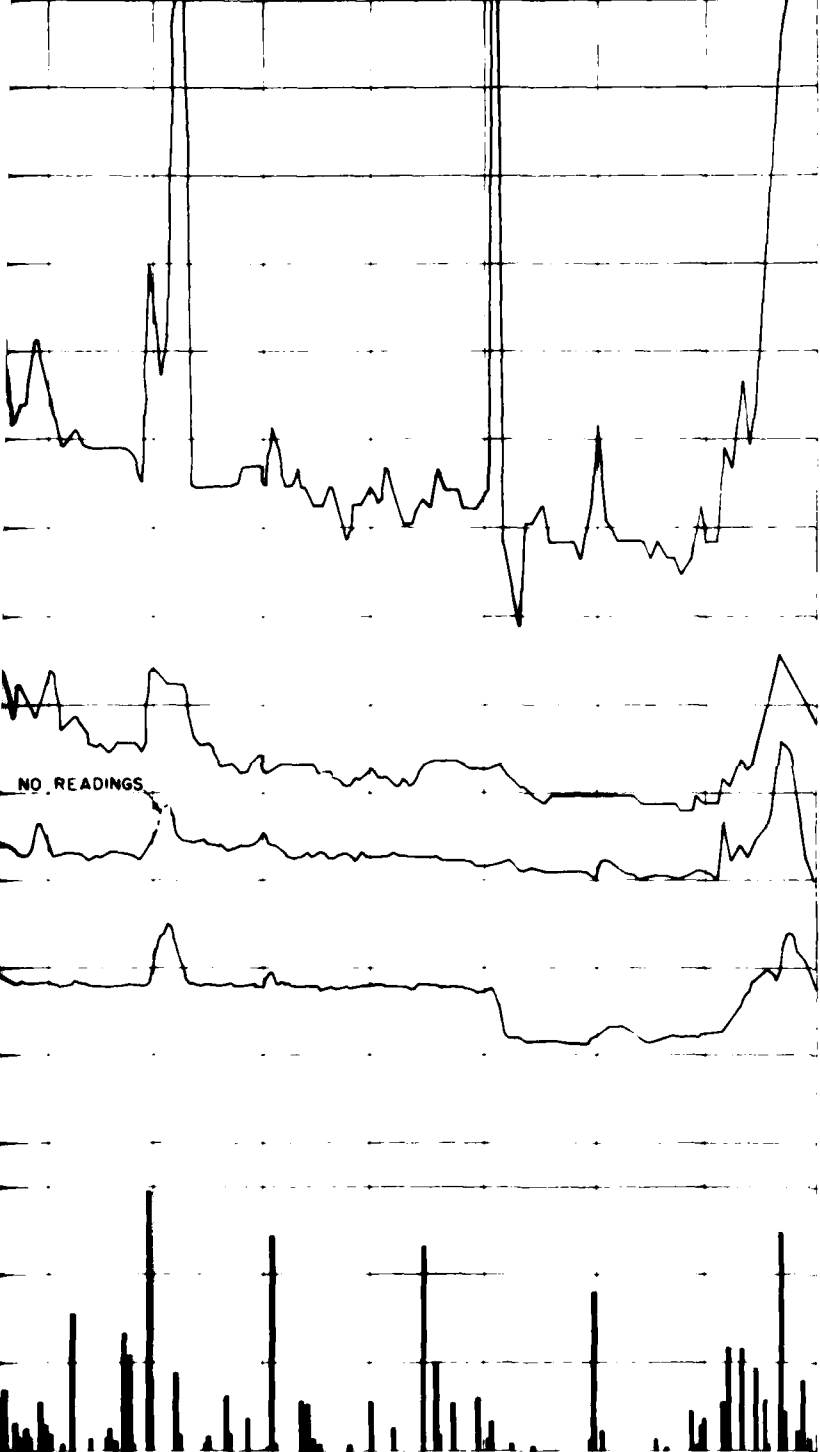
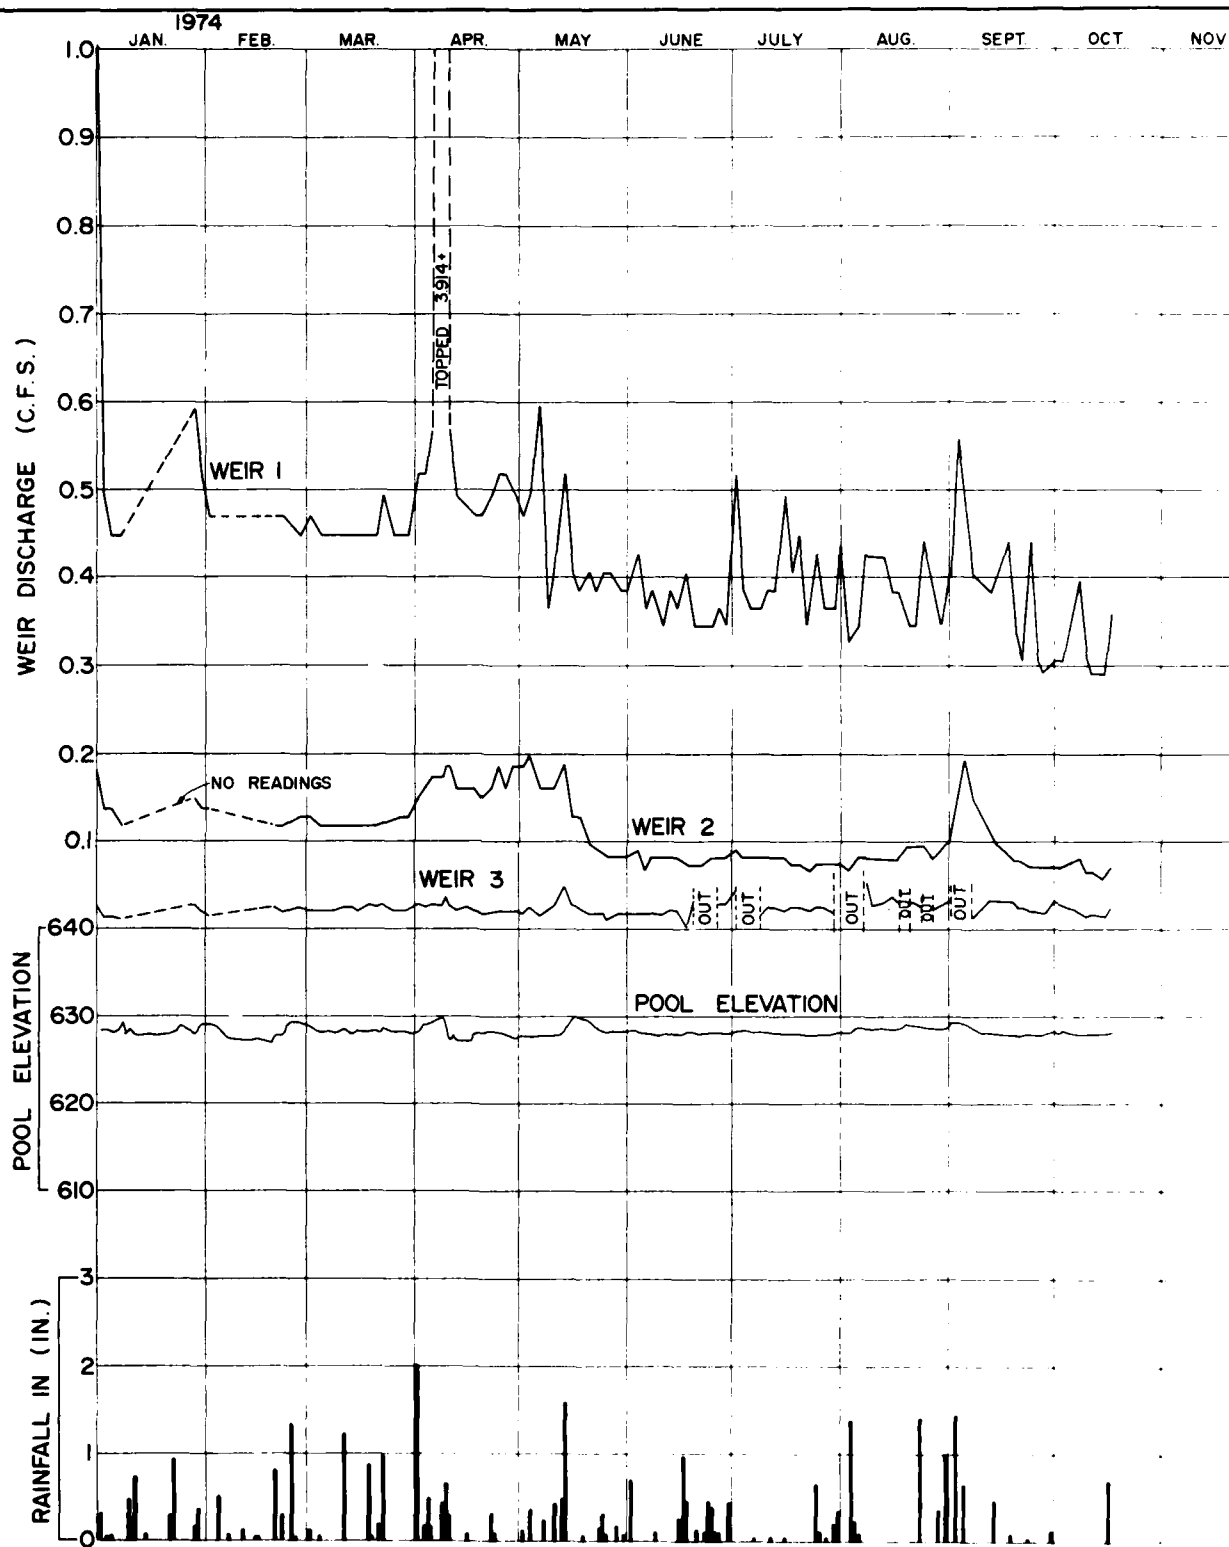
BELTZVILLE DAM & RESERVOIR  
WEIR DISCHARGE

- Small springs noted along left abutment downstream of dam (Periodic Inspection No. 2); seeps in rock cut to right of stilling basin had begun during preceding winter & continued throughout the summer, base flow of seepage along left abutment had increased during filling of the reservoir (Periodic Inspection No. 3). Installation and monitoring of weir system (Inspections 2 & 3) and seepage study (Periodic Inspection No. 3) recommended. The right abutment weir was not operational at Periodic Inspection No. 5.

c. Weirs - The right abutment weir was not operational at the time of the inspection. Repairs of this weir and continued readings of all weirs is recommended.

- Weirs installed, maintained and monitored. Evaluation of seepage condition submitted (Para 8, Periodic Inspection Report No. 3 and 4). Monitoring of weirs by operating personnel will continue on current schedule. Repair of the right abutment weir made by project personnel.
